Ground Truthing

RESULTS

Archaeological Desk-based Assessment

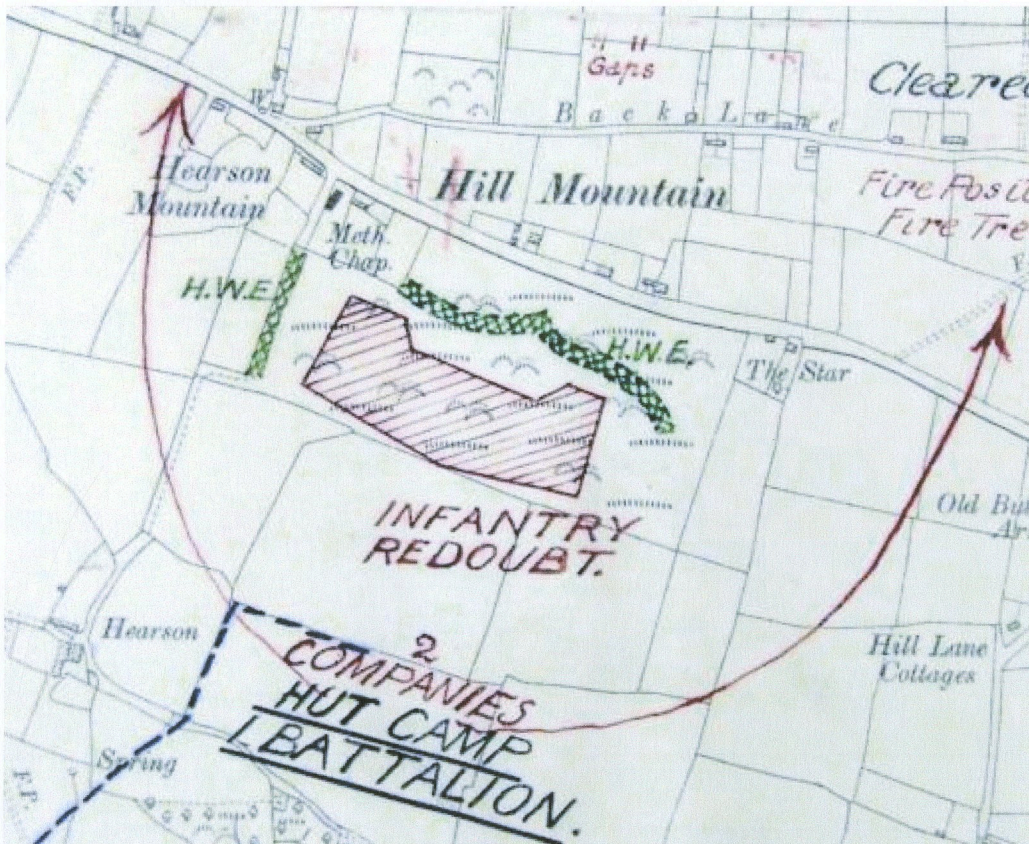
Figure 6: A site visit to the Infantry Redoubt and hut camp for 1 Battalion was undertaken

The War Office map of 1916 shows an infantry redoubt, shaded in red, indicating it was constructed, and High Wire Entanglements and the location of a Hut Camp at Hearson Farm.

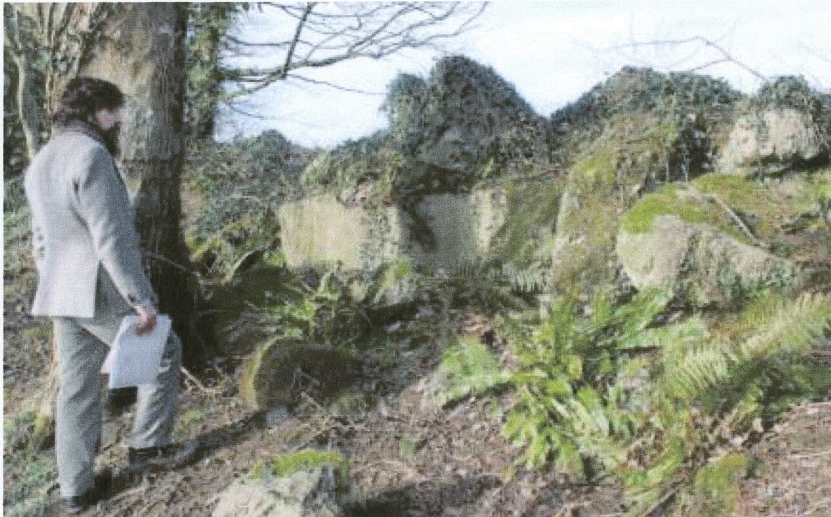
Figure 7: Ed Davies examining some of the broken up hut bases which formed part of the camp at Hearson Farm Pembrokeshire

No *in situ* remains were observed in these locations, however evidence of the hut camp was suggested in the southern perimeter of the field, where a large volume of concrete debris, brick, barbed wire and piping was observed. In addition artefactual material such as a glass bottle of "Camp" Coffee and Chicory lay amongst the debris.

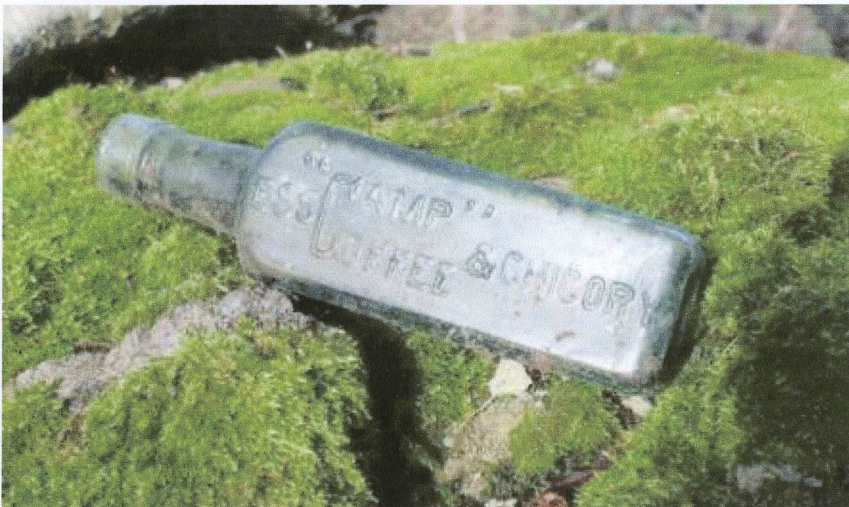
Figure 8: A 'Camp Coffee' bottle, a typical find for a First World War Camp.

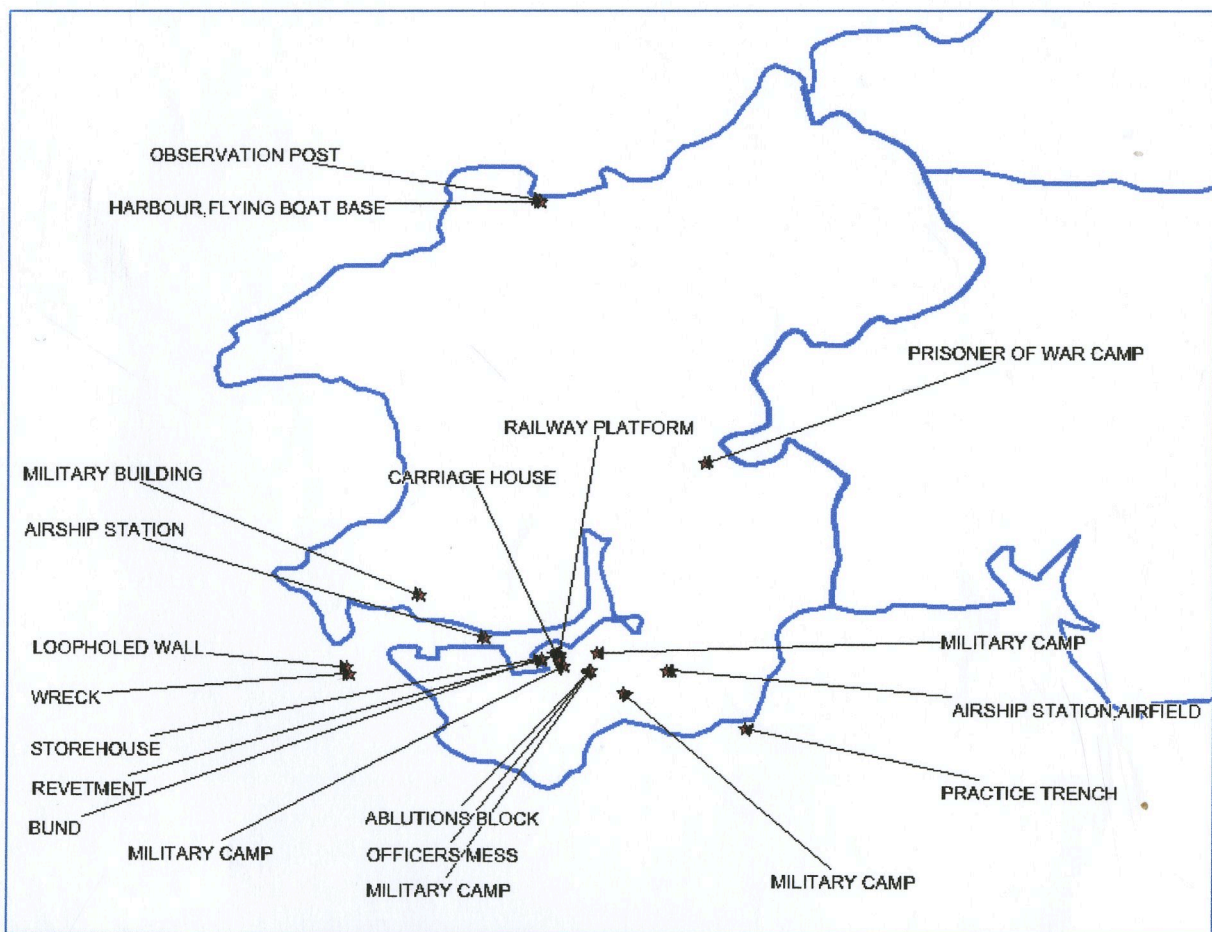
An initial enquiry of the Historic Environment Record (HER) shows the difficulty of identifying sites which relate to the period of the First World War. There is a field within the HER in which to enter a specific date; however this is not a mandatory field and many older records do not have this filled in. Within the mandatory 'PERIOD' field 'Modern' can be selected and further enquiry of the HER is through the free text search within the 'Summary' field. Investigation of this searching for dates (1914-1918) and terms; 'WW1' 'First World War' returned 30 sites within Pembrokeshire. A full list is in Appendix B and a map of their distribution given below (Fig. 1). No additional sites dating to the First World War were identified on Coflein.

Figure 1: Map showing distribution of HER points relating to First World War sites and structures

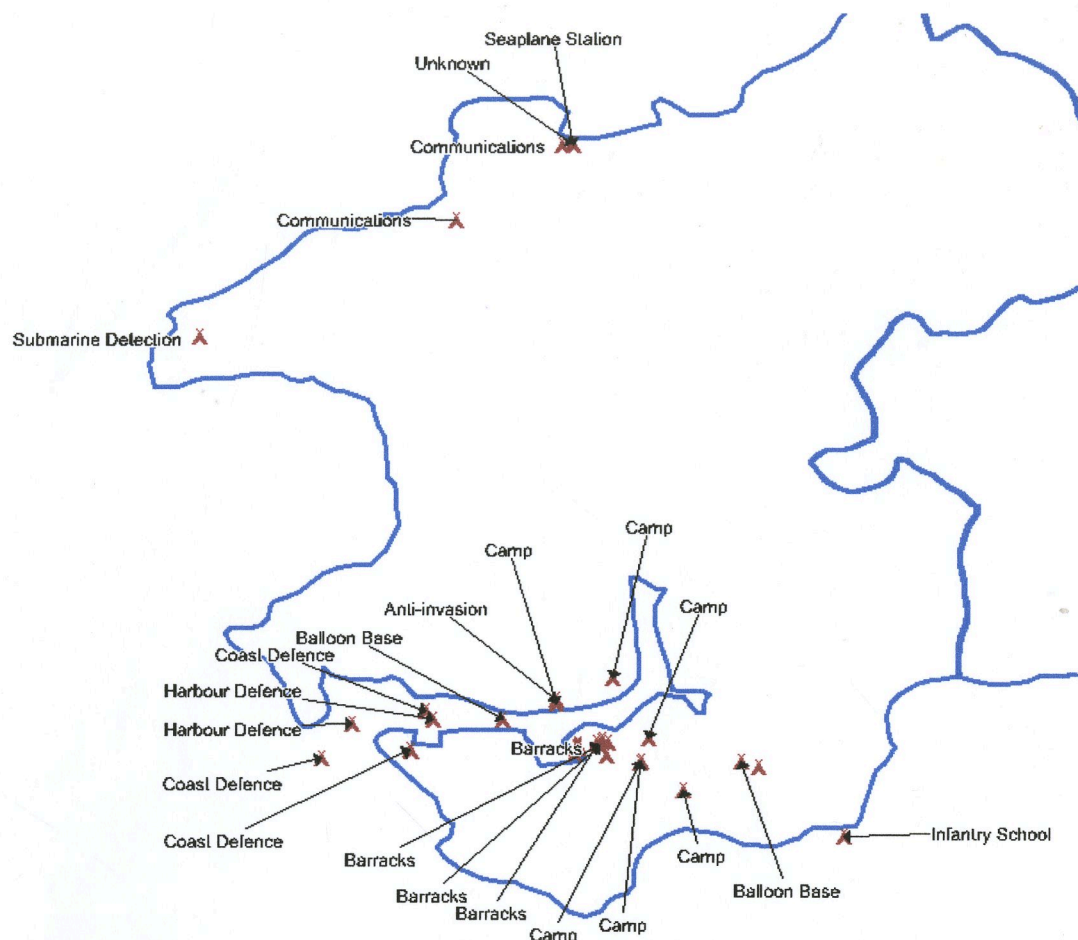
Many of these sites derive from Roger J C Thomas's survey of Military Buildings of Pembrokeshire of 1993 which has been incompletely transferred into the HER. Search of the database of R J C Thomas revealed 50 sites in total dating to this period of which 27 have been allocated Primary Reference Numbers (PRNs) and incorporated into the HER. As can be seen from the distribution map (Fig. 2) the majority of these sites lie in south Pembrokeshire and in particular around the Milford Haven Waterway at Llanion Barracks and Pembroke Dock. For a full list see Appendix C.

Figure 2: Map showing distribution of First World War sites in Roger Thomas's survey of 1993.
